# An Updated Assessment of Trail User Compliance and Trailside Erosion in Wildcat Creek, Tilden Regional Park, Berkeley California

Jennifer Podvin  
2014

East Bay Regional Park District Report

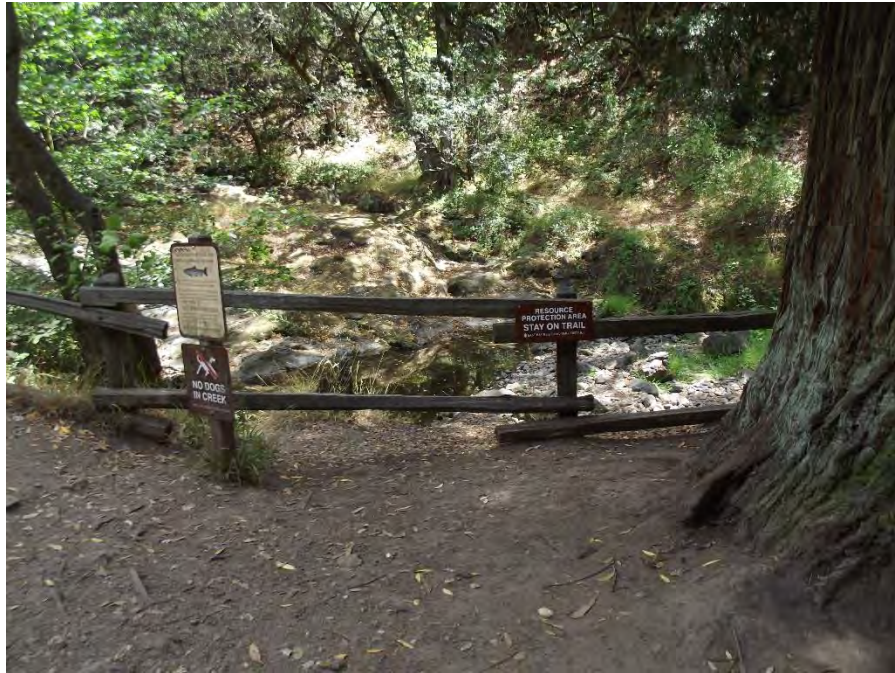
| Location | Description of site | Eroded<br>in m <sup>3</sup> | Trampled<br>in m <sup>2</sup> | Graul 2004<br>past site # | Naturally<br>Caused | Slope | Notes/ Recommendations<br>see appendix 3 for pictures |
|---|--|---|---|---|---|---|---|
| 1 | Nook Pool | YES | YES | 1 | NO | MODERATE | Right of sign, fencing in need of netting at the bottom to deter dogs. Fencing in need of repair further upstream (falling over). |

Location 1: Nook Pool. Netting should be applied here at the bottom of the fence. This was the most popular access point for dogs entering Nook bank and pool.

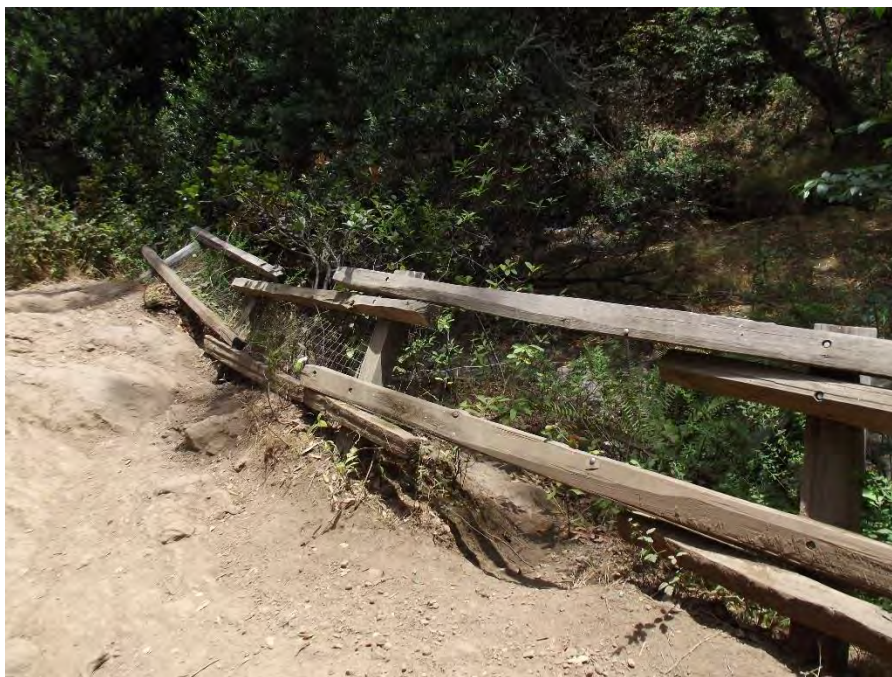
Location 1: Nook Pool. Further up the trail, this fence is falling over and in need of repair. Also netting should be placed at the bottom of the fence. This was the second most popular entry location for dogs entering Nook bank and pool.

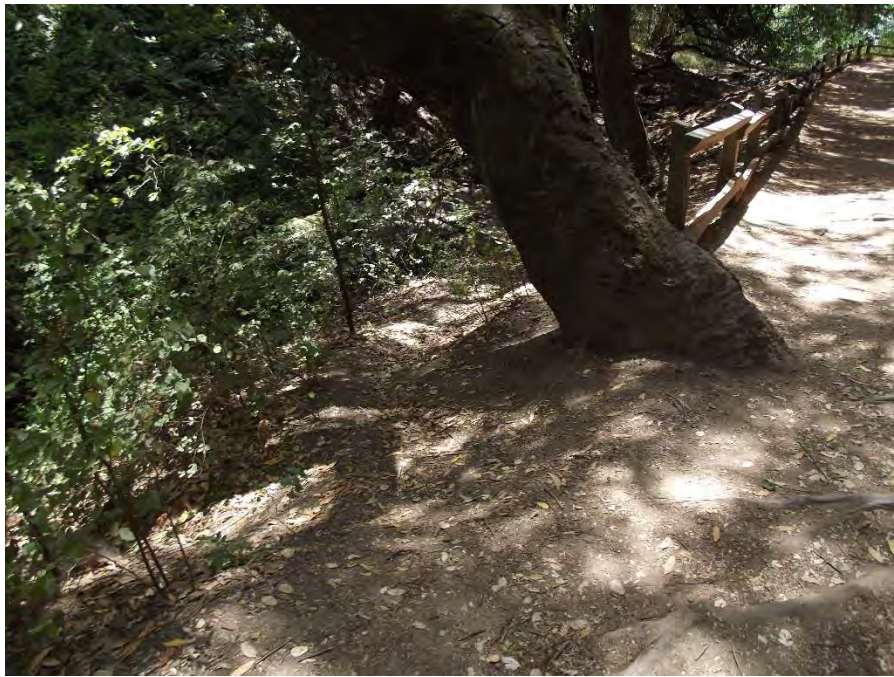
| Location | Description of site | Eroded<br>in m <sup>3</sup> | Trampled<br>in m <sup>2</sup> | Graul 2004<br>past site # | Naturally<br>Caused | Slope | Notes/ Recommendations<br>see appendix 3 for pictures |
|---|--|---|---|---|---|---|---|
| 2 | 1st split rail fence after Nook Pool | YES | YES | 2 | NO | MODERATE | Fence could be extended to deter hikers and dogs. |

**Location 2: 1st split-rail fence after Nook Pool (upstream). Here you see an obvious bootleg path leading to the creek. Fencing should be extended here to deter hikers and dogs.**

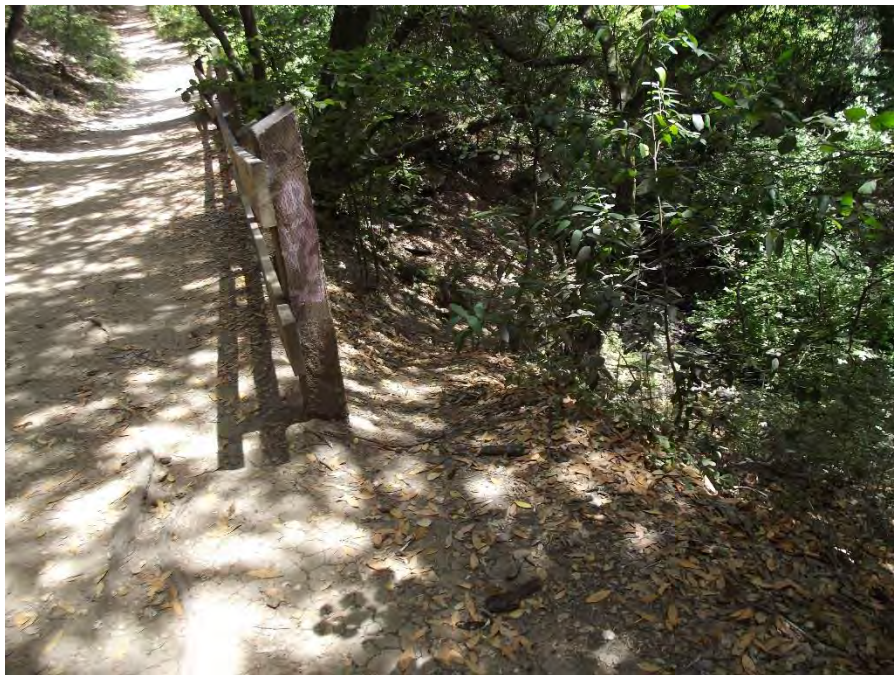
| Location | Description of site | Eroded<br>in m <sup>3</sup> | Trampled<br>in m <sup>2</sup> | Graul 2004<br>past site # | Naturally<br>Caused | Slope | Notes/ Recommendations<br>see appendix 3 for pictures |
|---|--|---|---|---|---|---|---|
| 3 | 2nd split rail fence after Nook Pool | YES | YES | 3 & 4 | YES | STEEP | Fence could be extended. Erosion appears to be caused by water from opposite side of trail (possible deer path to creek). |

**Location 3: 2nd split-rail fence upstream from Nook Pool. This steep trail appears to be caused by water erosion. Fencing should be extended to discourage animals or people from entering. A retaining wall could prevent further erosion.**

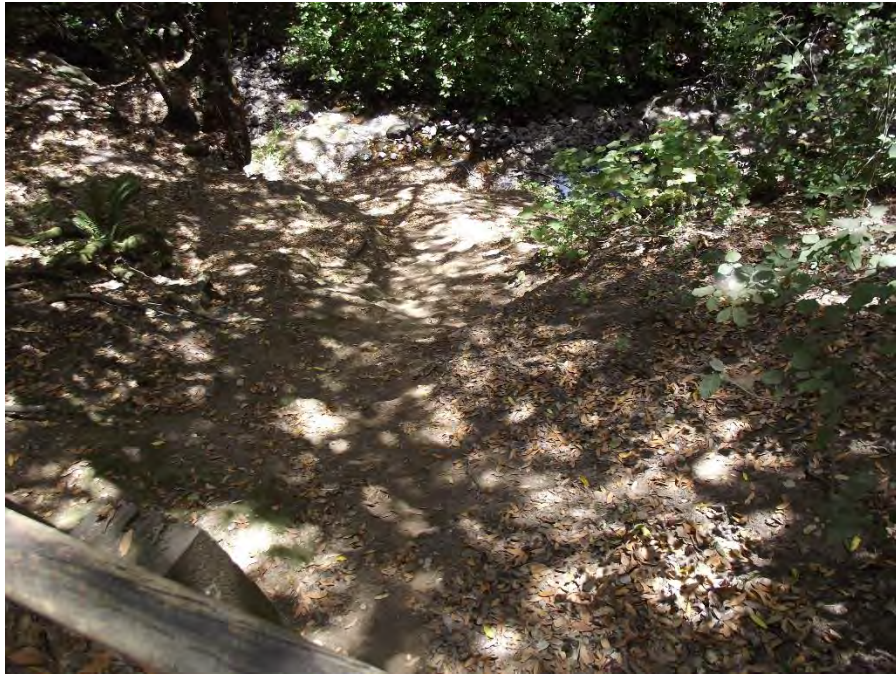
Location 3: Alternate view of steep, water eroded path leading directly to Wildcat Creek.

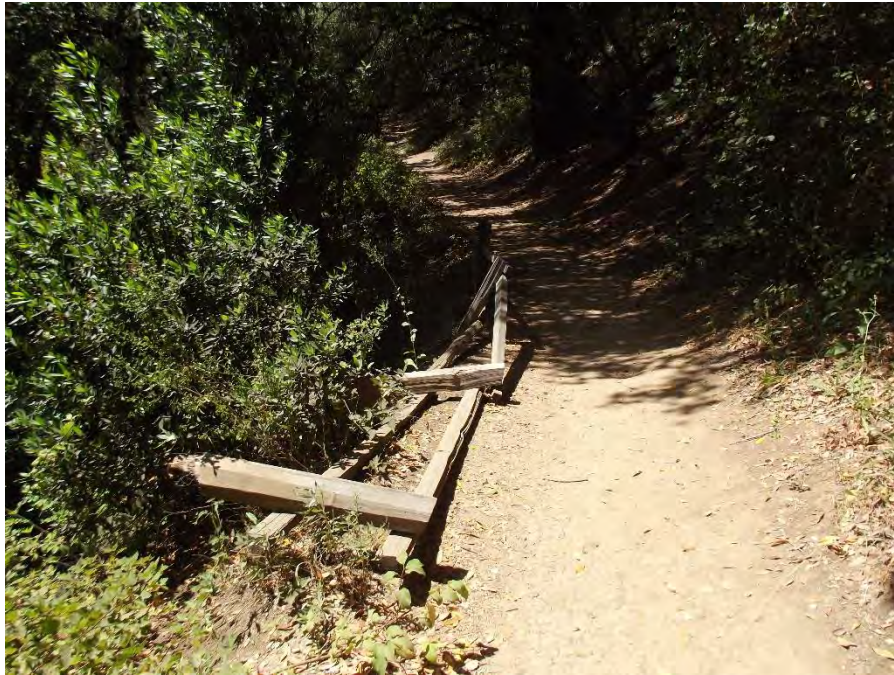
| Location | Description of site | Eroded<br>in m <sup>3</sup> | Trampled<br>in m <sup>2</sup> | Graul 2004<br>past site # | Naturally<br>Caused | Slope | Notes/ Recommendations<br>see appendix 3 for pictures |
|---|--|---|---|---|---|---|---|
| 4 | Up stream from site 3 | NO | NO | NA | NA | GRADUAL | Fence in need of repair (falling over). |

Location 4: Upstream from site 3. Fence in need of repair.

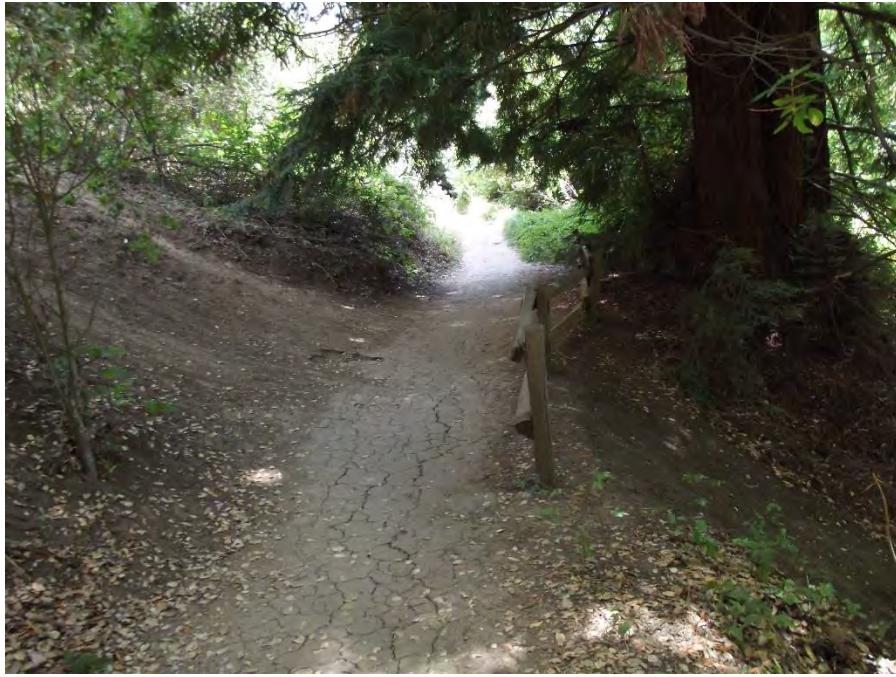
| Location | Description of site | Eroded<br>in m <sup>3</sup> | Trampled<br>in m <sup>2</sup> | Graul 2004<br>past site # | Naturally<br>Caused | Slope | Notes/ Recommendations<br>see appendix 3 for pictures |
|---|--|---|---|---|---|---|---|
| 5 | 3rd split rail fence after Nook Pool (Redwood tree) | YES | NO | 9 | YES | STEEP | Water erosion from upper trail. |

**Location 5: 3rd split-rail fence upstream from Nook Pool (at large Redwood tree). Here water erosion from the opposite of the trail is evident. A retaining wall could be effective for reducing the amount of erosion entering Wildcat Creek.**

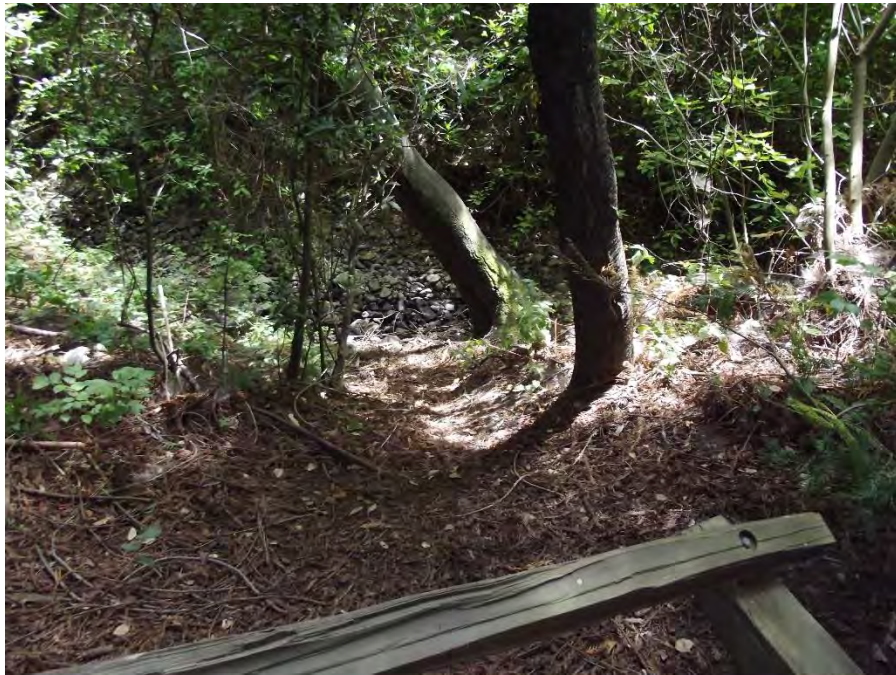
**Location 6: Redwood grove. Fencing is falling over and in need of repair. Bootleg trail is very close to creek—a very easy access point for people and dogs.**

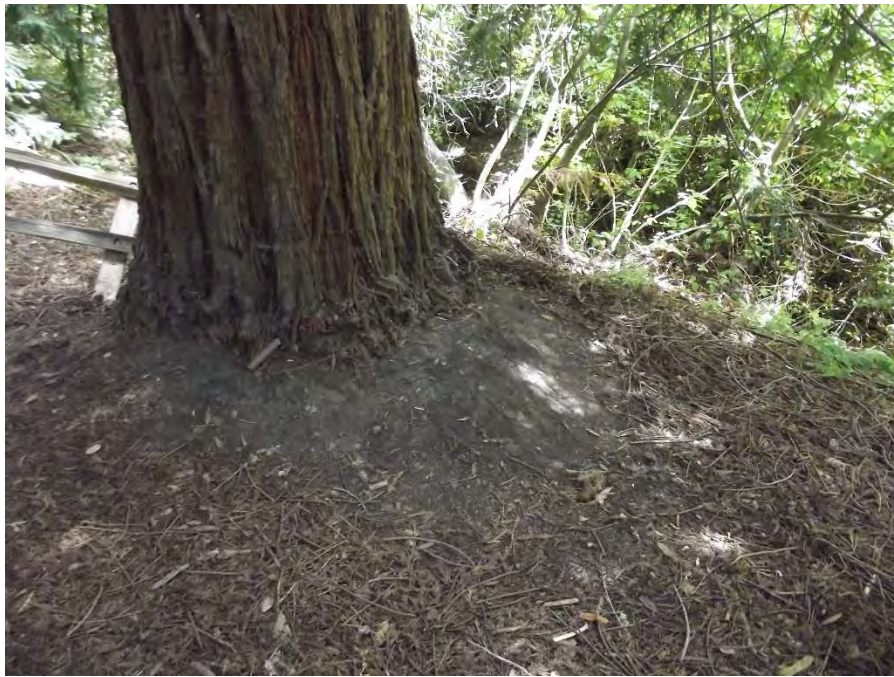
| Location | Description of site | Eroded<br>in m <sup>3</sup> | Trampled<br>in m <sup>2</sup> | Graul 2004<br>past site # | Naturally<br>Caused | Slope | Notes/ Recommendations<br>see appendix 3 for pictures |
|---|--|---|---|---|---|---|---|
| 6 | Redwood grove | NO | YES | NA | NO | GRADUAL | Extending fence would help with trampling around Redwood trees. |

**Location 6: Redwood grove. Trampling around Redwood trees could be prevented by repairing and extending fencing (to the left) of the tree.**

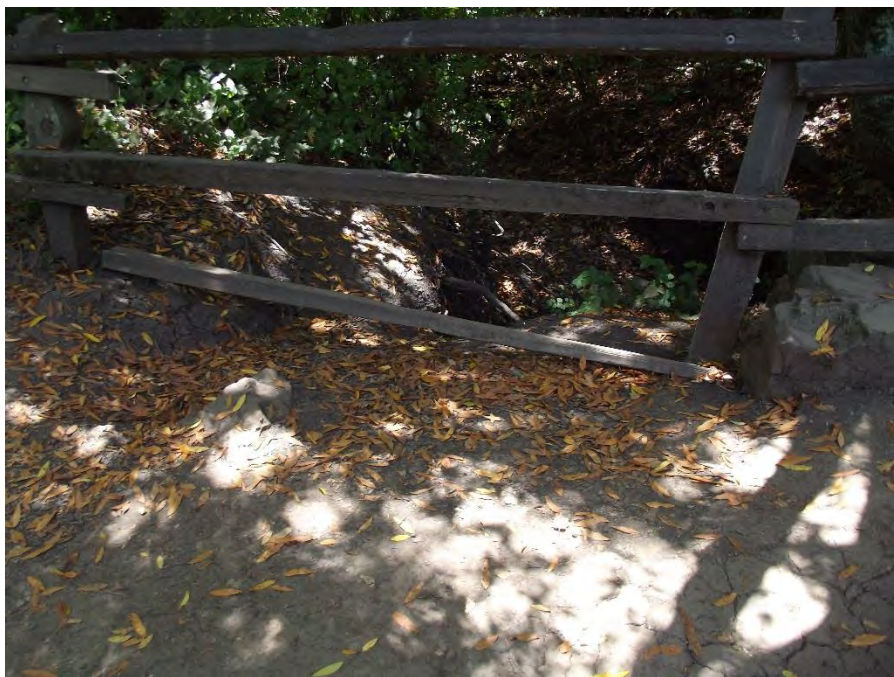
| Location | Description of site | Eroded<br>in m <sup>3</sup> | Trampled<br>in m <sup>2</sup> | Graul 2004<br>past site # | Naturally<br>Caused | Slope | Notes/ Recommendations<br>see appendix 3 for pictures |
|---|--|---|---|---|---|---|---|
| 7 | Stone culvert | YES | NO | NA | YES | MODERATE | Water erosion from upper trail. |

**Location 7: Stone culvert. This site is also experiencing erosion from water runoff which is draining directly into a tributary. A retaining wall is recommended.**

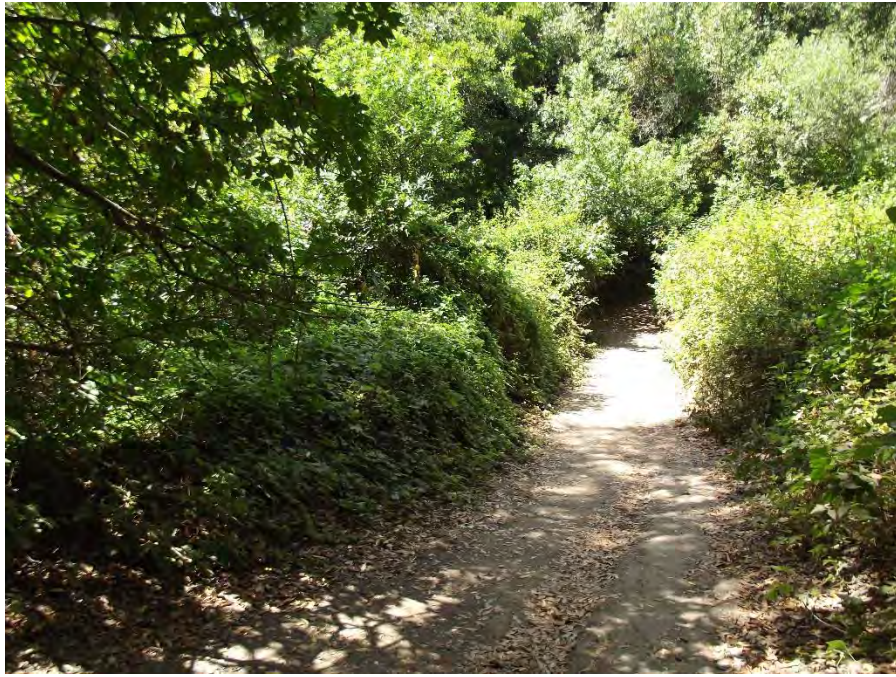
| Location | Description of site | Eroded<br>in m <sup>3</sup> | Trampled<br>in m <sup>2</sup> | Graul 2004<br>past site # | Naturally<br>Caused | Slope | Notes/ Recommendations<br>see appendix 3 for pictures |
|---|--|---|---|---|---|---|---|
| 8 | Upstream from culvert | NO | NO | 12 | NA | GRADUAL | This area was once trampled but is now grown over with brambles. |

**Location 8: Upstream from stone culvert. This site was identified as location #12 from Graul's 2004 study, a once trampled area is now overgrown with Himalayan Blackberry.**

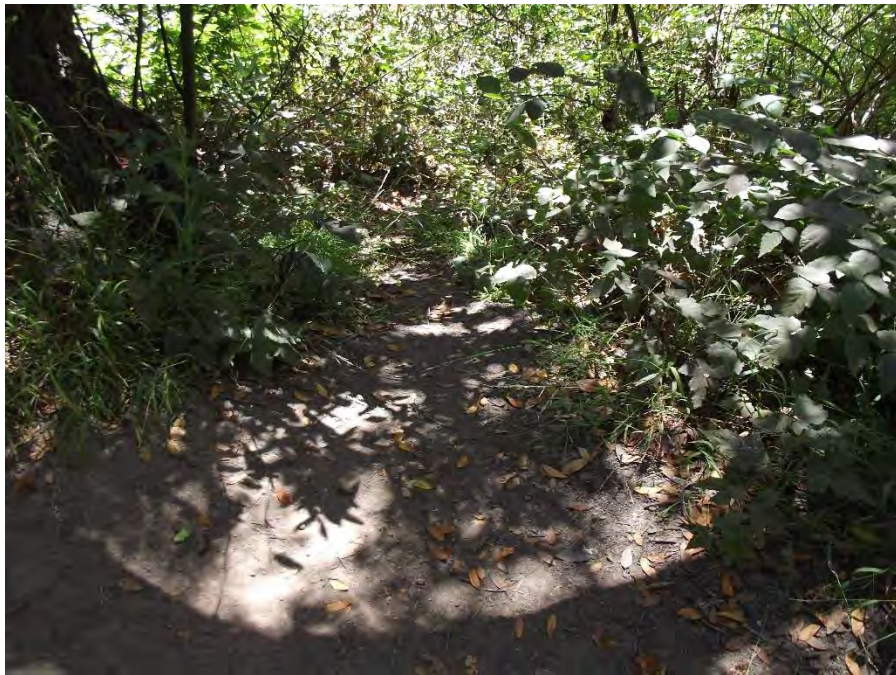
| Location | Description of site | Eroded<br>in m <sup>3</sup> | Trampled<br>in m <sup>2</sup> | Graul 2004<br>past site # | Naturally<br>Caused | Slope | Notes/ Recommendations<br>see appendix 3 for pictures |
|---|--|---|---|---|---|---|---|
| 9 | Under Bay tree on right before large Bay (with hole) on left side of trail | NO | YES | 13 | NO | MODERATE | Mostly recovered, still some trampling evident. |

**Location 9: Under large bay tree on right side of trail (on opposite side of trail from large bay tree with hole in trunk). Site #13 from Graul's 2004 study appears to be recovering but is still showing signs of trampling. A fence could be erected here to discourage people and animals from entering.**

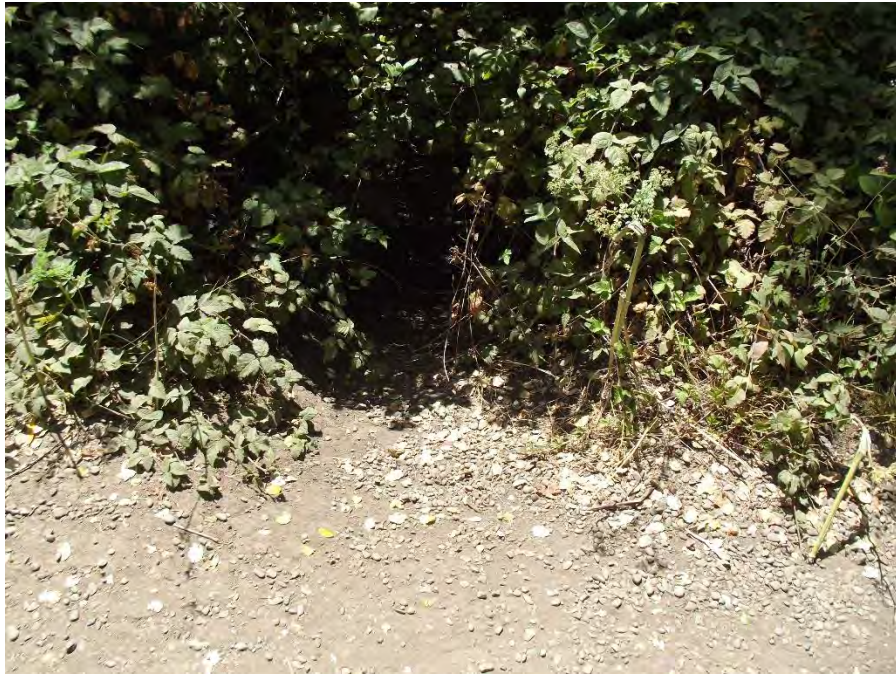
| Location | Description of site | Eroded<br>in m <sup>3</sup> | Trampled<br>in m <sup>2</sup> | Graul 2004<br>past site # | Naturally<br>Caused | Slope | Notes/ Recommendations<br>see appendix 3 for pictures |
|---|--|---|---|---|---|---|---|
| 10 | Upstream from bay trees | YES | NO | NA | YES | MODERATE | Appears to be deer or wildlife trail. |

**Location 10:** Upstream from bay trees. These trails appear to be caused by wildlife, likely deer. The creek is about 5 meters from the trail here.

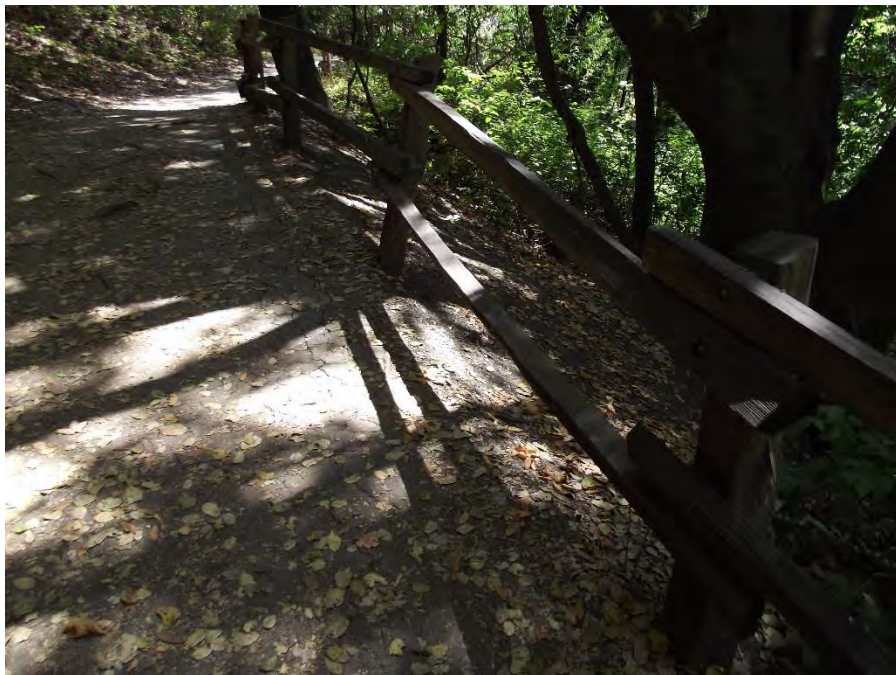
| Location | Description of site | Eroded<br>in m <sup>3</sup> | Trampled<br>in m <sup>2</sup> | Graul 2004<br>past site # | Naturally<br>Caused | Slope | Notes/ Recommendations<br>see appendix 3 for pictures |
|---|--|---|---|---|---|---|---|
| 11 | 1st split rail fence after bay trees and at large bay tree | YES | NO | 14 | YES | STEEP | Water runoff from upper trail. Still in need of revegetation. |

**Location 11:** 1st split-rail fence upstream from bay trees at large bay tree. Water erosion is again evident from opposite side of trail. Re-vegetation or a retaining wall is recommended.

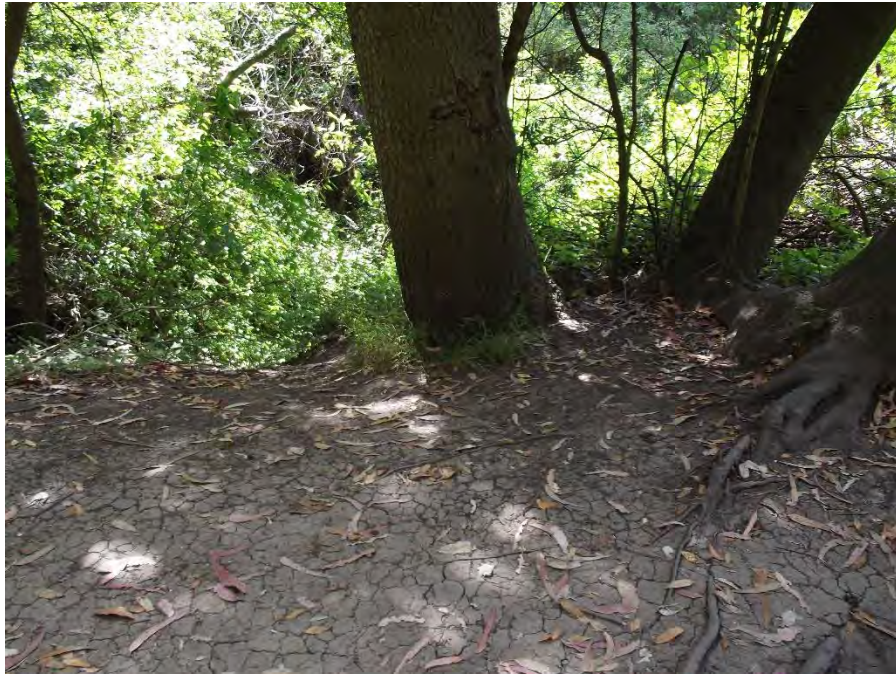
| Location | Description of site | Eroded<br>in m <sup>3</sup> | Trampled<br>in m <sup>2</sup> | Graul 2004<br>past site # | Naturally<br>Caused | Slope | Notes/ Recommendations<br>see appendix 3 for pictures |
|---|--|---|---|---|---|---|---|
| 12 | Just before split rail fence at Redwoods near 3 large bay trees | NO | YES | NA | NO | GRADUAL | Fence should be extended to discourage bootleg trail. |

**Location 12: Just before split rail fence at Redwoods near three large bay trees. Fencing should be extended to cut off bootleg trail.**

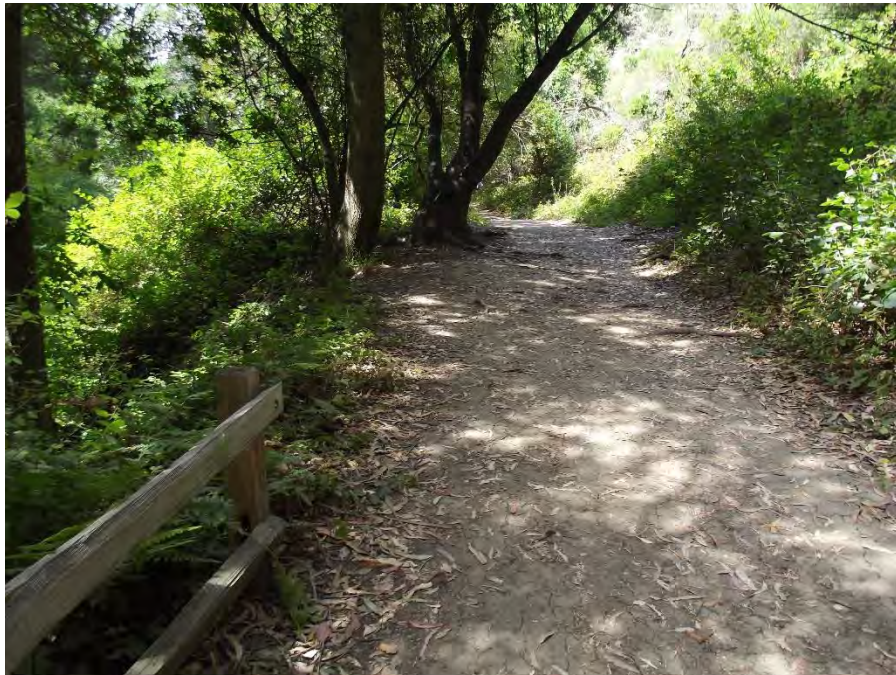
**Location 12: Alternate view showing where fence ends and should be extended to bay trees.**

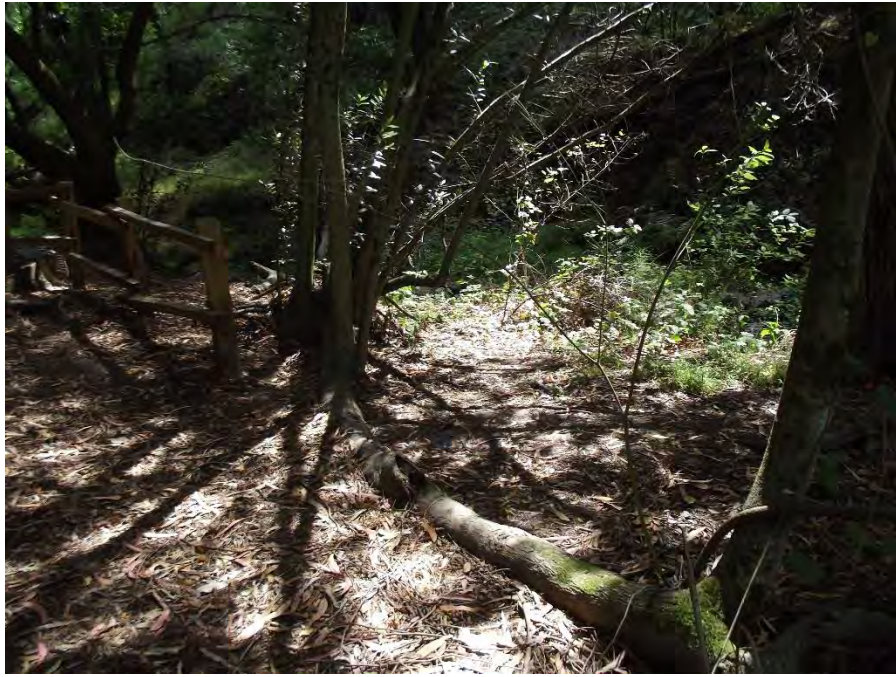
| Location | Description of site | Eroded<br>in m <sup>3</sup> | Trampled<br>in m <sup>2</sup> | Graul 2004<br>past site # | Naturally<br>Caused | Slope | Notes/ Recommendations<br>see appendix 3 for pictures |
|---|--|---|---|---|---|---|---|
| 13 | Beginning of split rail fence at 2 Redwoods | NO | YES | NA | NA | GRADUAL | Fence should be extended to discourage bootleg trail. *Very close to creek, easy access. Netting needs repaired. |

**Location 13: Beginning of split-rail fence at 2 large Redwoods. Fencing should be extended here and netting added/repaired. This location is very flat and close to the creek providing very easy access for hikers and dogs.**

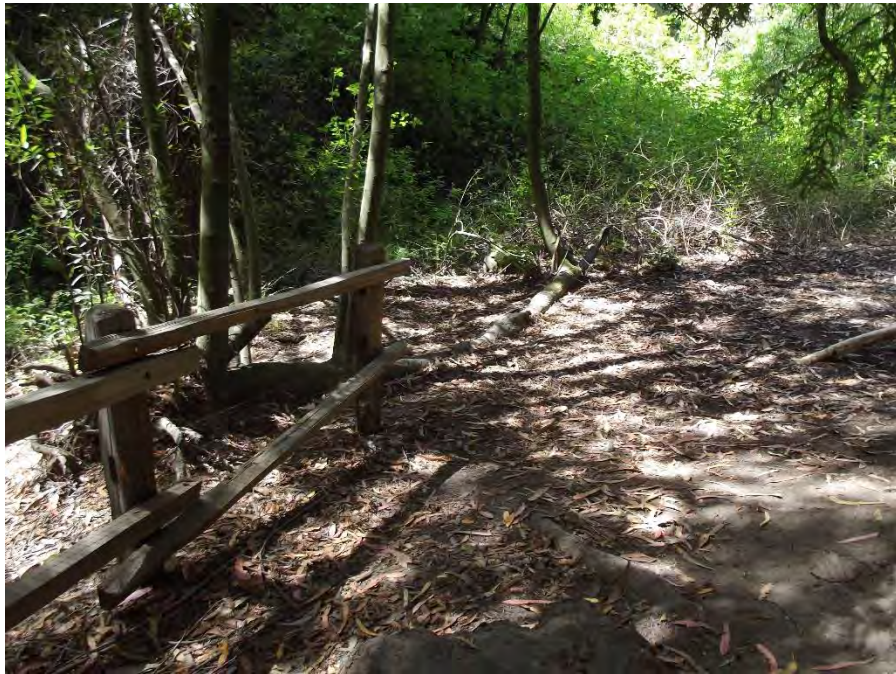
**Location 13: Alternate view showing where fencing should be extended to the right.**

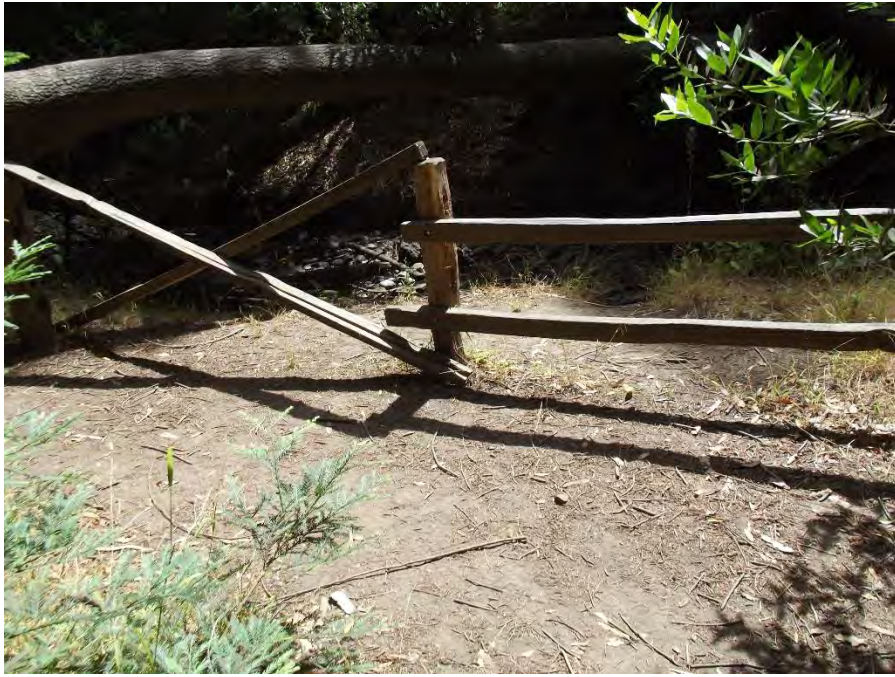
| Location | Description of site | Eroded<br>in m <sup>3</sup> | Trampled<br>in m <sup>2</sup> | Graul 2004<br>past site # | Naturally<br>Caused | Slope | Notes/ Recommendations<br>see appendix 3 for pictures |
|---|--|---|---|---|---|---|---|
| 14 | End of split rail fence near 2 Redwoods and 1 bay | YES | YES | 16 | NO | GRADUAL | Fence needs repaired, *very close to close to creek with easy access. Witnessed a dog entering while measuring. |

**Location 14: End of split-rail fence near 2 large Redwoods. Fencing is in need of repair and netting installed. This area is extremely close to the creek and is very easy to access.**

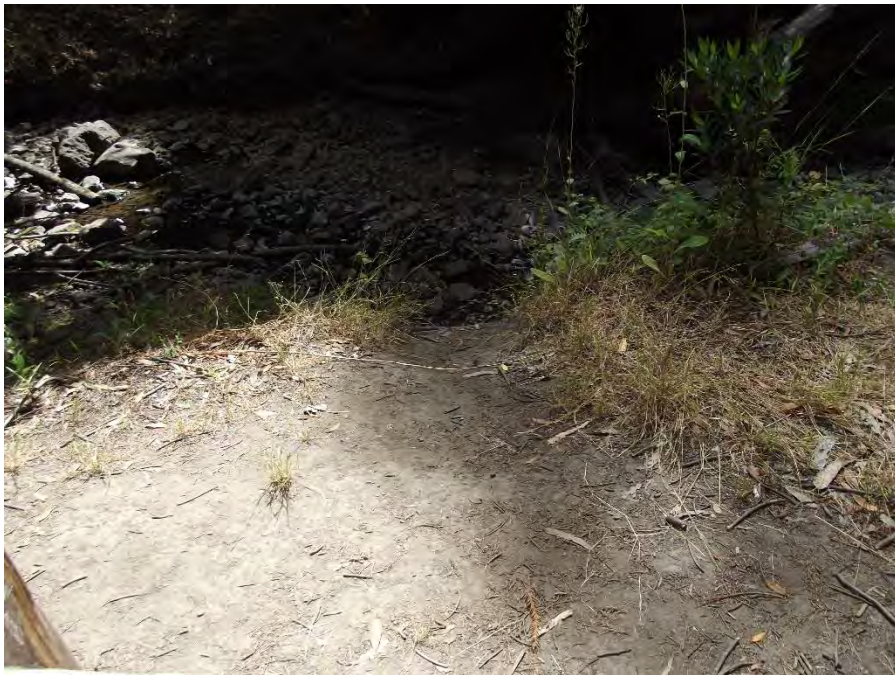
**Location 14: Alternate view showing trampling and close proximity of Wildcat Creek.**

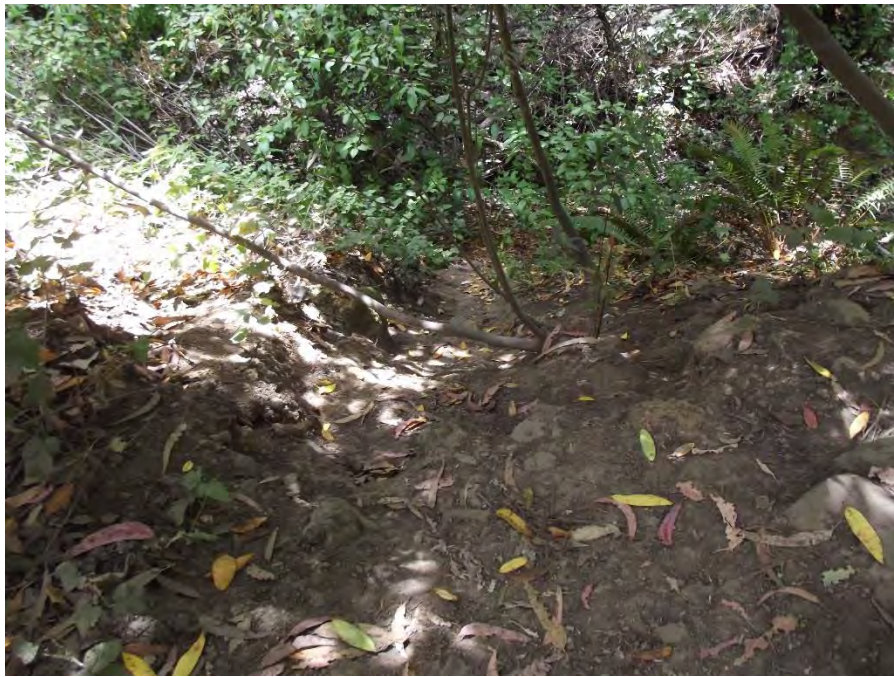
| Location | Description of site | Eroded<br>in m <sup>3</sup> | Trampled<br>in m <sup>2</sup> | Graul 2004<br>past site # | Naturally<br>Caused | Slope | Notes/ Recommendations<br>see appendix 3 for pictures |
|---|--|---|---|---|---|---|---|
| 15 | Upstream of redwood fence | YES | NO | 17 | UNCERTAIN | STEEP | Fence needed. |

**Location 15:** Upstream from redwood fence. Erosion is evident but it is uncertain how it was caused. A fence should be erected to deter hikers and animals from entering.

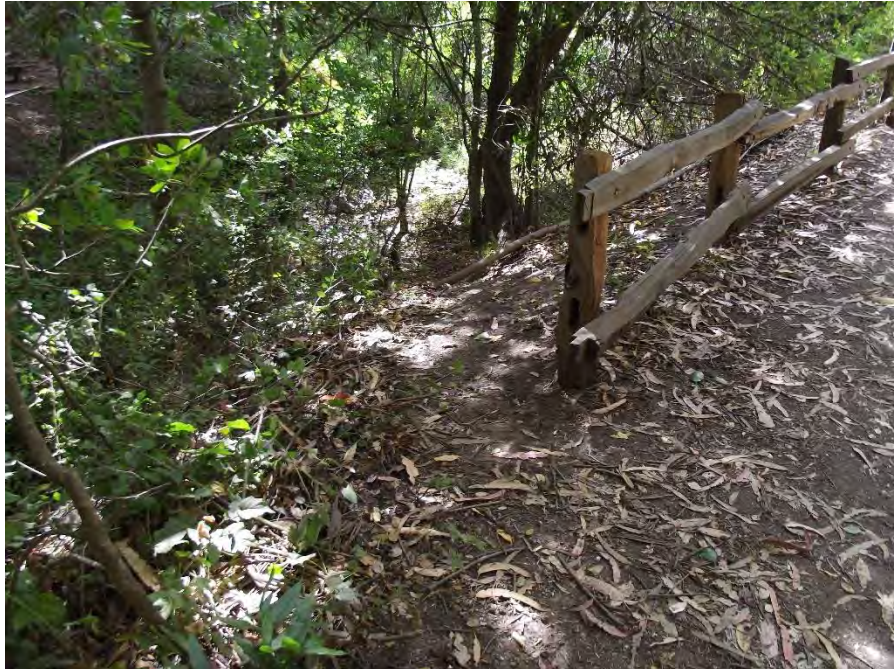
| Location | Description of site | Eroded<br>in m <sup>3</sup> | Trampled<br>in m <sup>2</sup> | Graul 2004<br>past site # | Naturally<br>Caused | Slope | Notes/ Recommendations<br>see appendix 3 for pictures |
|---|--|---|---|---|---|---|---|
| 16 | Fence upstream of site 15 near 3 Redwoods | NO | YES | NA | NO | GRADUAL | Very easy access to creek; a tapered fence could deter visitors. |

**Location 16:** Fence upstream from location 15 near 3 redwoods. Trampling was abundant here and the creek easily accessed; a tapered or extended fence could discourage visitors and dogs from entering.

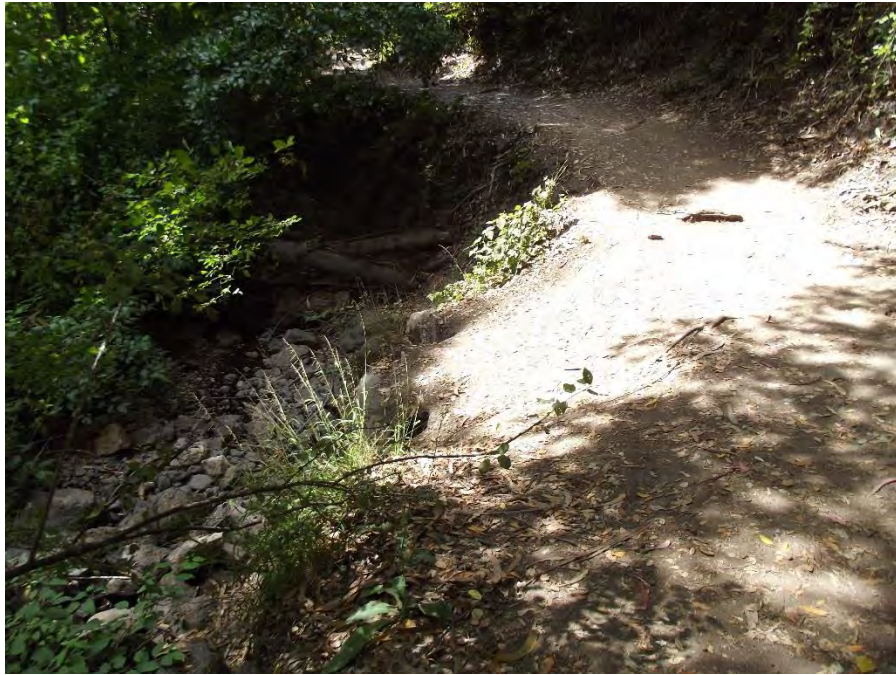
| Location | Description of site | Eroded<br>in m <sup>3</sup> | Trampled<br>in m <sup>2</sup> | Graul 2004<br>past site # | Naturally<br>Caused | Slope | Notes/ Recommendations<br>see appendix 3 for pictures |
|---|--|---|---|---|---|---|---|
| 17 | Upstream from site 16 | YES | YES | NA | YES | STEEP | Water erosion evident; easy access to creek. Connect fences. |

Location 17: Upstream from location 16. Water erosion is evident but the creek is also easily accessed from here, there is a fence both before and after this location—the fence should be connected and a retaining wall erected to discourage further erosion.

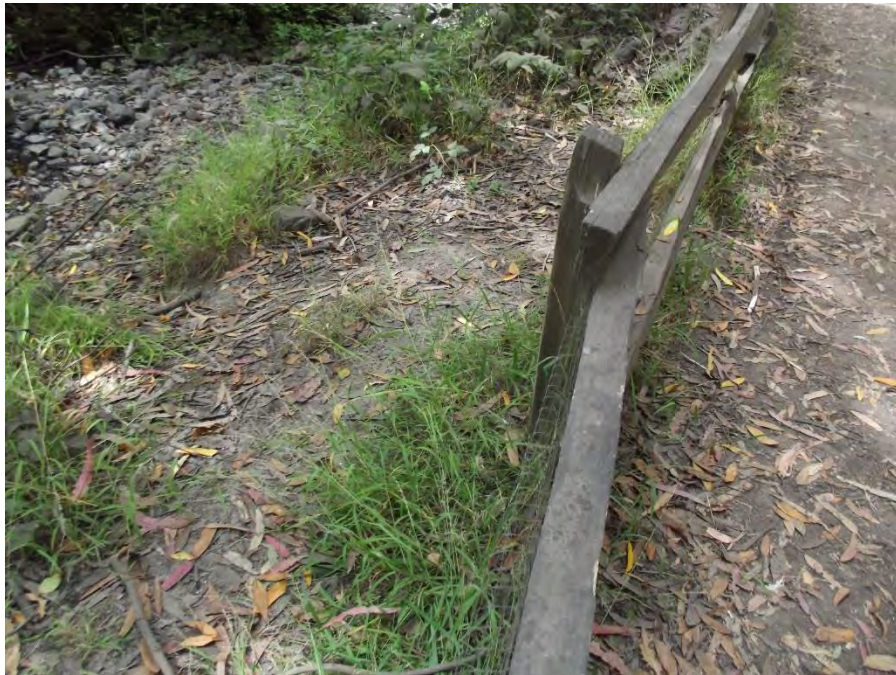
| Location | Description of site | Eroded<br>in m <sup>3</sup> | Trampled<br>in m <sup>2</sup> | Graul 2004<br>past site # | Naturally<br>Caused | Slope | Notes/ Recommendations<br>see appendix 3 for pictures |
|---|--|---|---|---|---|---|---|
| 18 | Beginning of 2nd fence upstream from site 17, before Brook pool | YES | YES | NA | NO | GRADUAL | Trampling along fence, seems to be still in the process of recovery; not recently used. Mesh at fence bottom recommended. |

Location 18: Beginning of 2<sup>nd</sup> fence upstream from site 17, just before Brook Pool. Trampling is still evident along the inside of the fence although there appears to be some recovery in the form of vegetation growing (note the abundance of the invasive grass *Erharta erecta* which was observed along the length of the trail near fences). Mesh at the bottom of fence is recommended.

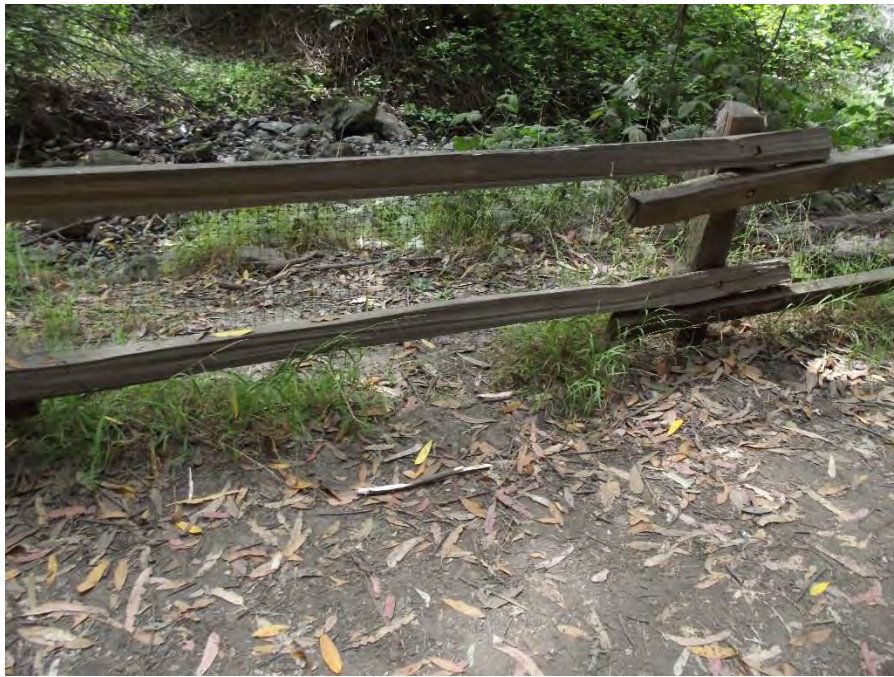
**Location 18: Alternate view showing the need for mesh on bottom of fence.**

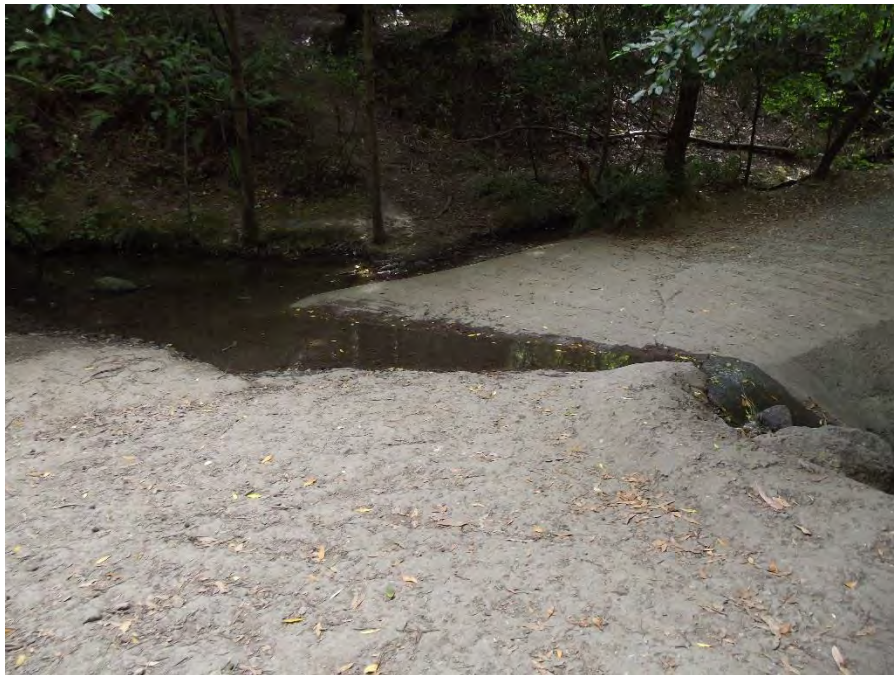
| Location | Description of site | Eroded<br>in m <sup>3</sup> | Trampled<br>in m <sup>2</sup> | Graul 2004<br>past site # | Naturally<br>Caused | Slope | Notes/ Recommendations<br>see appendix 3 for pictures |
|---|--|---|---|---|---|---|---|
| 19 | Just before Brook Pool | NO | YES | 20 | NO | GRADUAL | Bank in recovery but still much bare ground. A bridge is recommended over the creek at Brook Pool. |

**Location 19: Brook Pool. Banks appear to be recovering but dogs and people cannot avoid walking in the stream here and this location is sensitive as Brook Pool (which is habitat for trout and newts) is directly underneath this location. A bridge is highly recommended.**

we believe much can be averted by simply adding mesh to the bottom of fences in strategic places, tapering and extending fencing where needed and establishing a leash law. Finally a bridge should be built over Brook Pool as we observed many times that dogs and people could not help but enter the water at this location (see appendix 2 and 3).
