Harmful Algal Blooms (HABs) 2023 Annual Report

East Bay Regional Park District's Monitoring and Remediation Program Summary

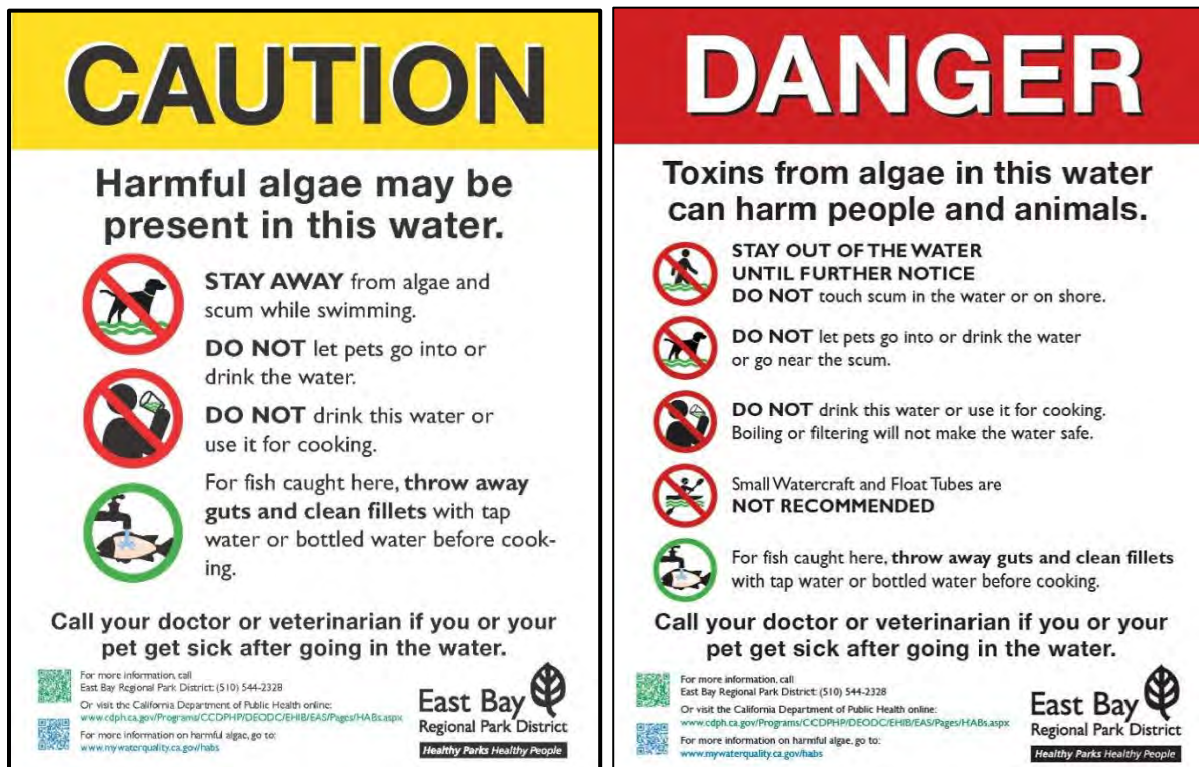
Figure 1. The East Bay Regional Park District’s HABs advisory signage.

In 2023, the Park District continues to send regular (weekly or bi-weekly) lake conditions and monitoring updates to stakeholders from state and local regulatory agencies, internal groups, and various park and water municipality partners. Public outreach occurred via [website](#) [postings](#) and physical signage postings at swim areas, park entrances, and known dog accessible entry points (Figure 1).

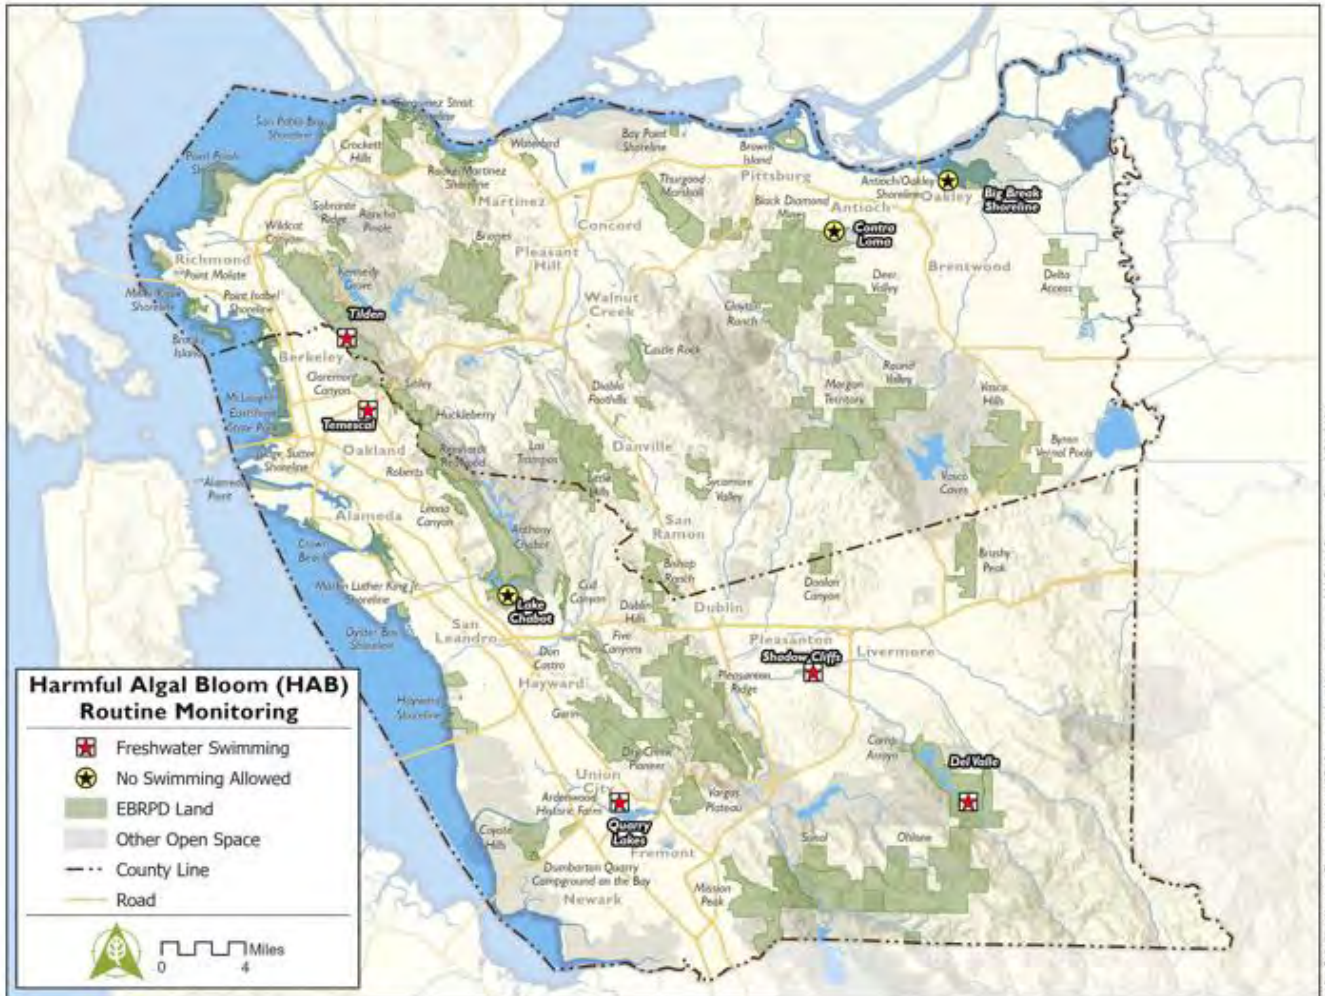
Figure 2. Map of routine HABs monitoring locations, represented by red stars. Locations are as follows: Contra Loma, Big Break, Lake Anza, Lake Temescal, Lake Chabot, Shadow Cliffs, Quarry Lakes, and Del Valle.

The Park District performed routine monitoring at eight different parks (Figure 2) and periodic monitoring at a handful of other locations in 2023. Periodic monitoring took place when trained staff were dispatched to non-routine locations for other workstreams and were able to batch HABs monitoring into the same field day. Cyanotoxin testing took place depending on need-based factors including recreational usage, visual observations, and current advisory postings.

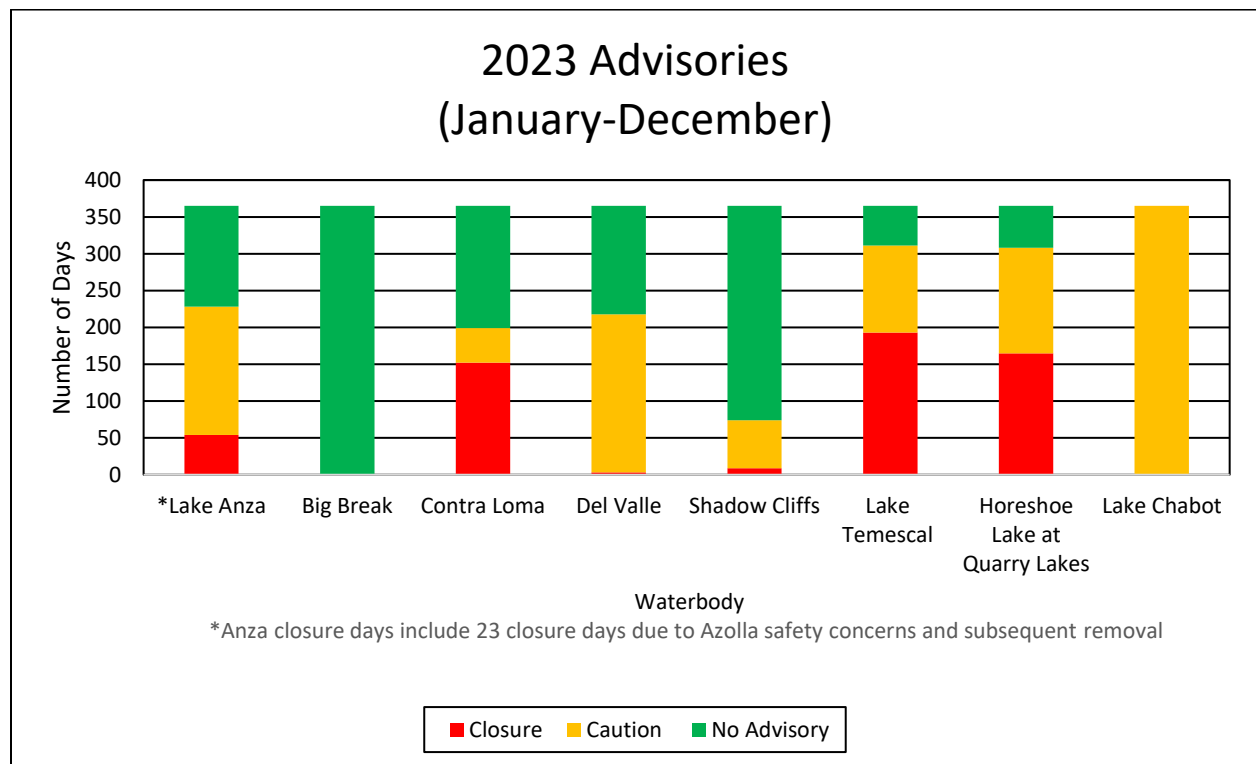
Figure 3. 2023 HABs advisories at all Park District fresh waterbodies.

The Park District experienced many HABs related advisory postings and closures in 2023. In general, these advisories are prompted by cyanobacteria toxin tests, but the presence of benthic cyanobacteria will also prompt a Caution advisory. Figure 3 shows a breakdown of all advisories and closures at Park District reservoirs and lakes, including waterbodies that do not allow body contact. This year also saw the re-opening of two swimming areas that had formerly been closed for years. Lake Anza re-opened to swimming after being closed since 2019 due to maintenance issues and COVID restrictions. Shadow Cliffs Reservoir also re-opened to swimming this year after closing to swimming and boating in 2020 due to low water levels.

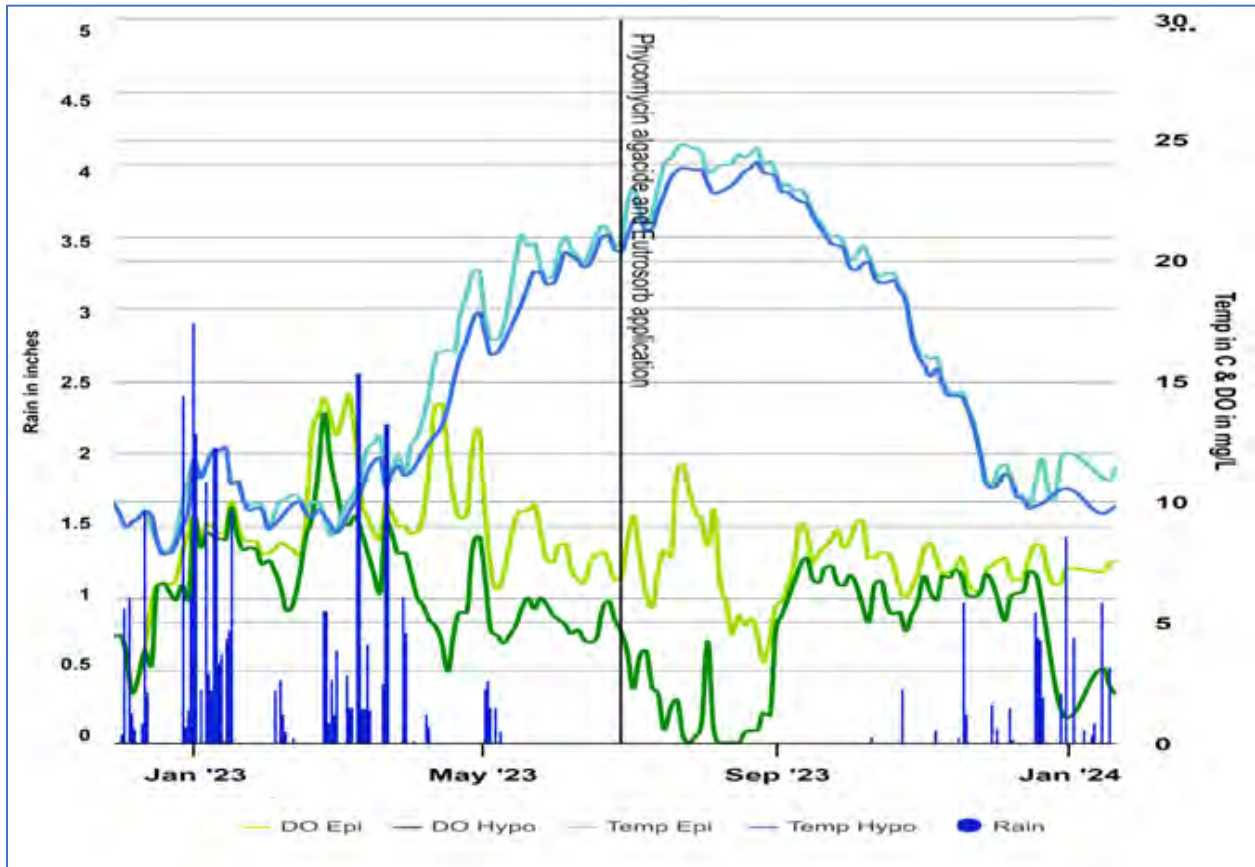
Figure 7. Temperature and dissolved oxygen data reported by two real-time loggers at Lake Temescal. One logger is in the epilimnion (1 meter) and the other in the hypolimnion (4 meters).

Figure 7 shows the temperature and DO data collected by the real-time loggers in 2023. Notably, the lake experienced periods of anoxia in the hypolimnion that coincided with some of the worst bloom conditions in July and August 2023. Figure 8 shows an increase in orthophosphate during the periods of anoxia.

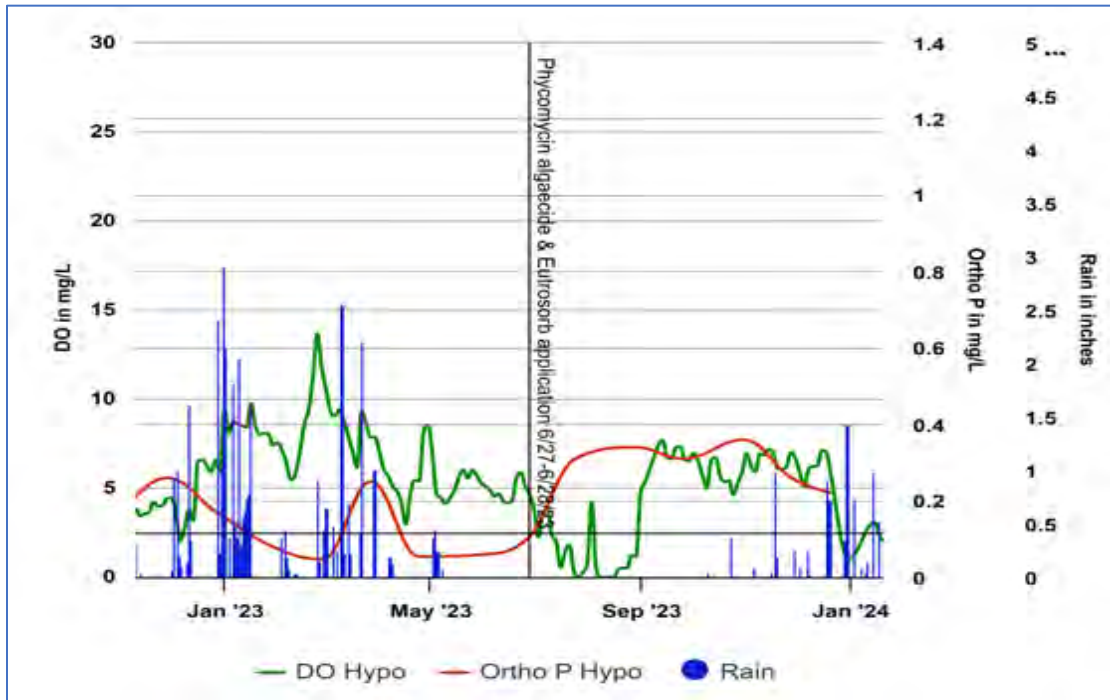
Figure 8. Real-time dissolved oxygen data and monthly nutrient Orthophosphate as P data in the hypolimnion.

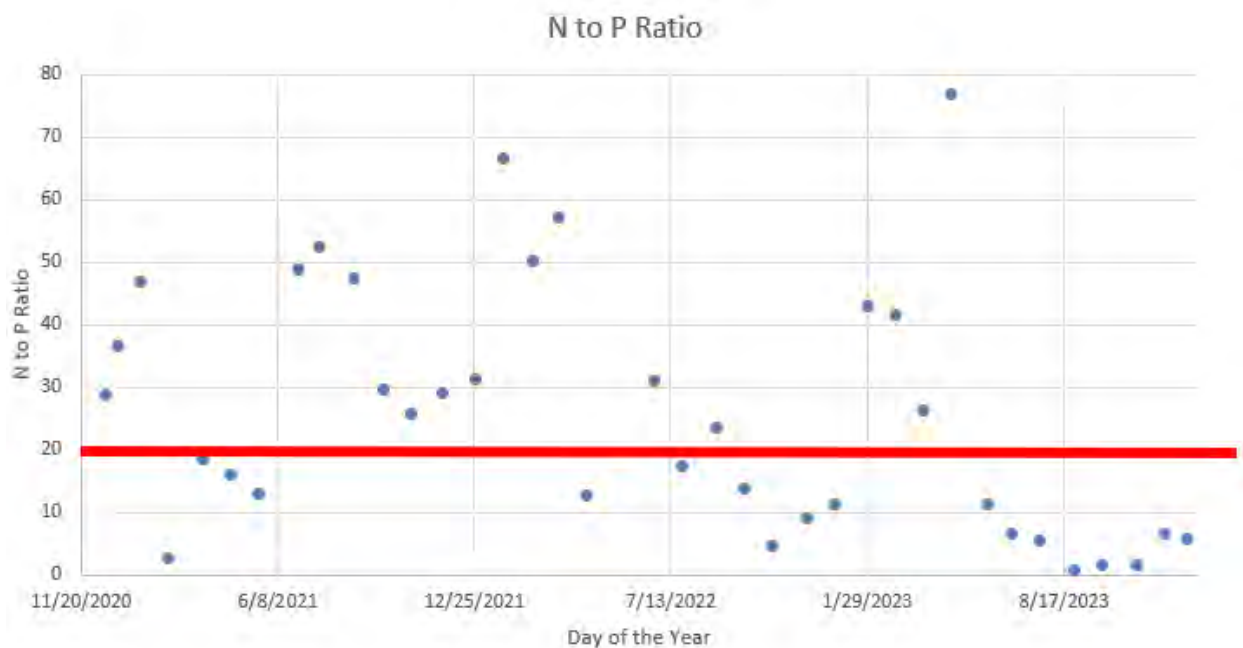
Figure 10. Nitrogen to Phosphorus ratio at Lake Temescal (The red line indicates a 20 to 1 N to P ratio, which can be used as a conservative alert for cyanobacteria biomass/toxins to increase, if the ratio drops below).

Figure 10 shows the nitrogen to phosphorus ratios at Lake Temescal since the end of 2020. External nitrogen loading during the winter has the N to P ratios consistently start out high in the spring and then decline until they become low in the fall. We saw low N to P ratios starting in May of 2023 and continuing for the remainder of the year; this corresponded with high cyanobacteria toxins from June through October. An N to P ratio of 20 to 1 can be used as a

conservative warning sign for a pending bloom or an increase of toxins, should the ratio further decrease towards 10 and below.

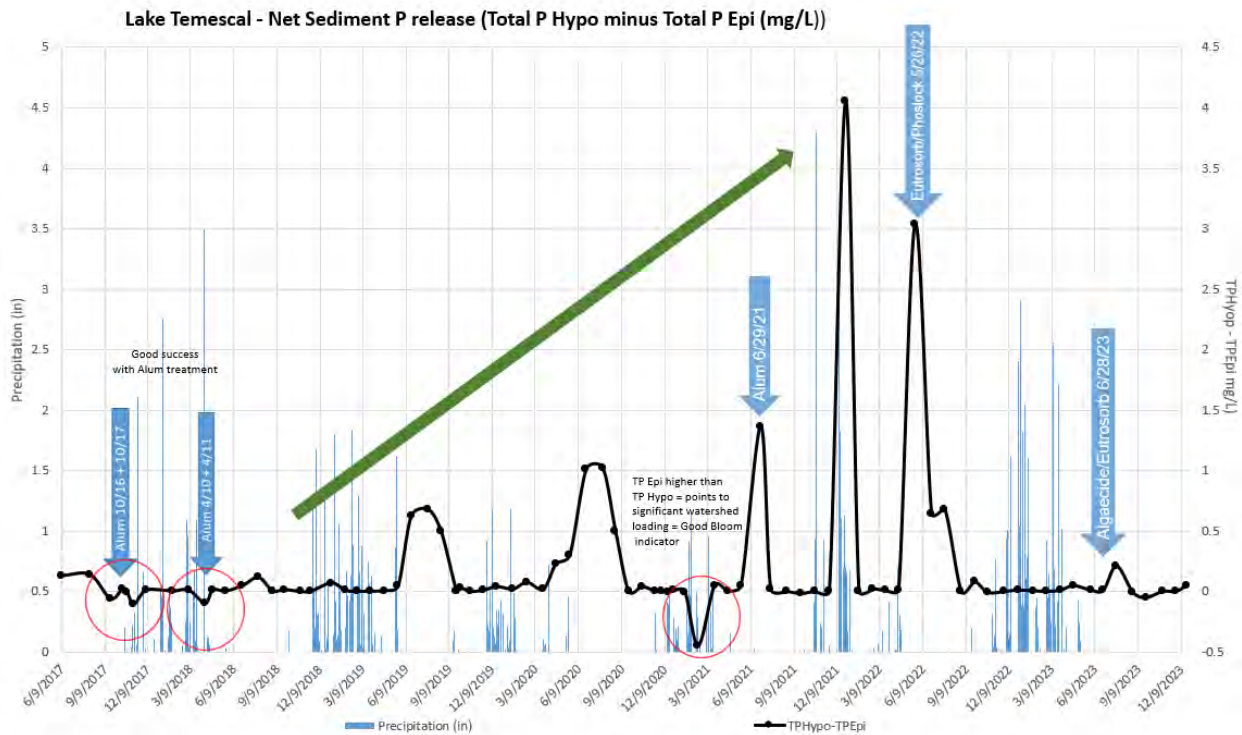
Figure 11. Increased internal phosphorus loading and treatments.

Figure 11 displays the net sediment P release (calculated by subtracting Total P at the epilimnion from Total P at the hypolimnion) and an increase of internal loading year by year starting in 2019, after 2 successful alum treatments. Spikes during 2021 and 2022 treatments lead to the assumption that the applications occurred too late in the season to prevent the release. The prolonged storm season in 2023 changed the typical early anoxia pattern through cooler lake temperatures and the lake treatment in June seemed to have been effective in preventing a significant release. The Park District also explored the possibility of installing an aeration system in Lake Temescal in 2023. The idea was ultimately dismissed due to a lack of staffing to oversee installation, management, and maintenance of the system.

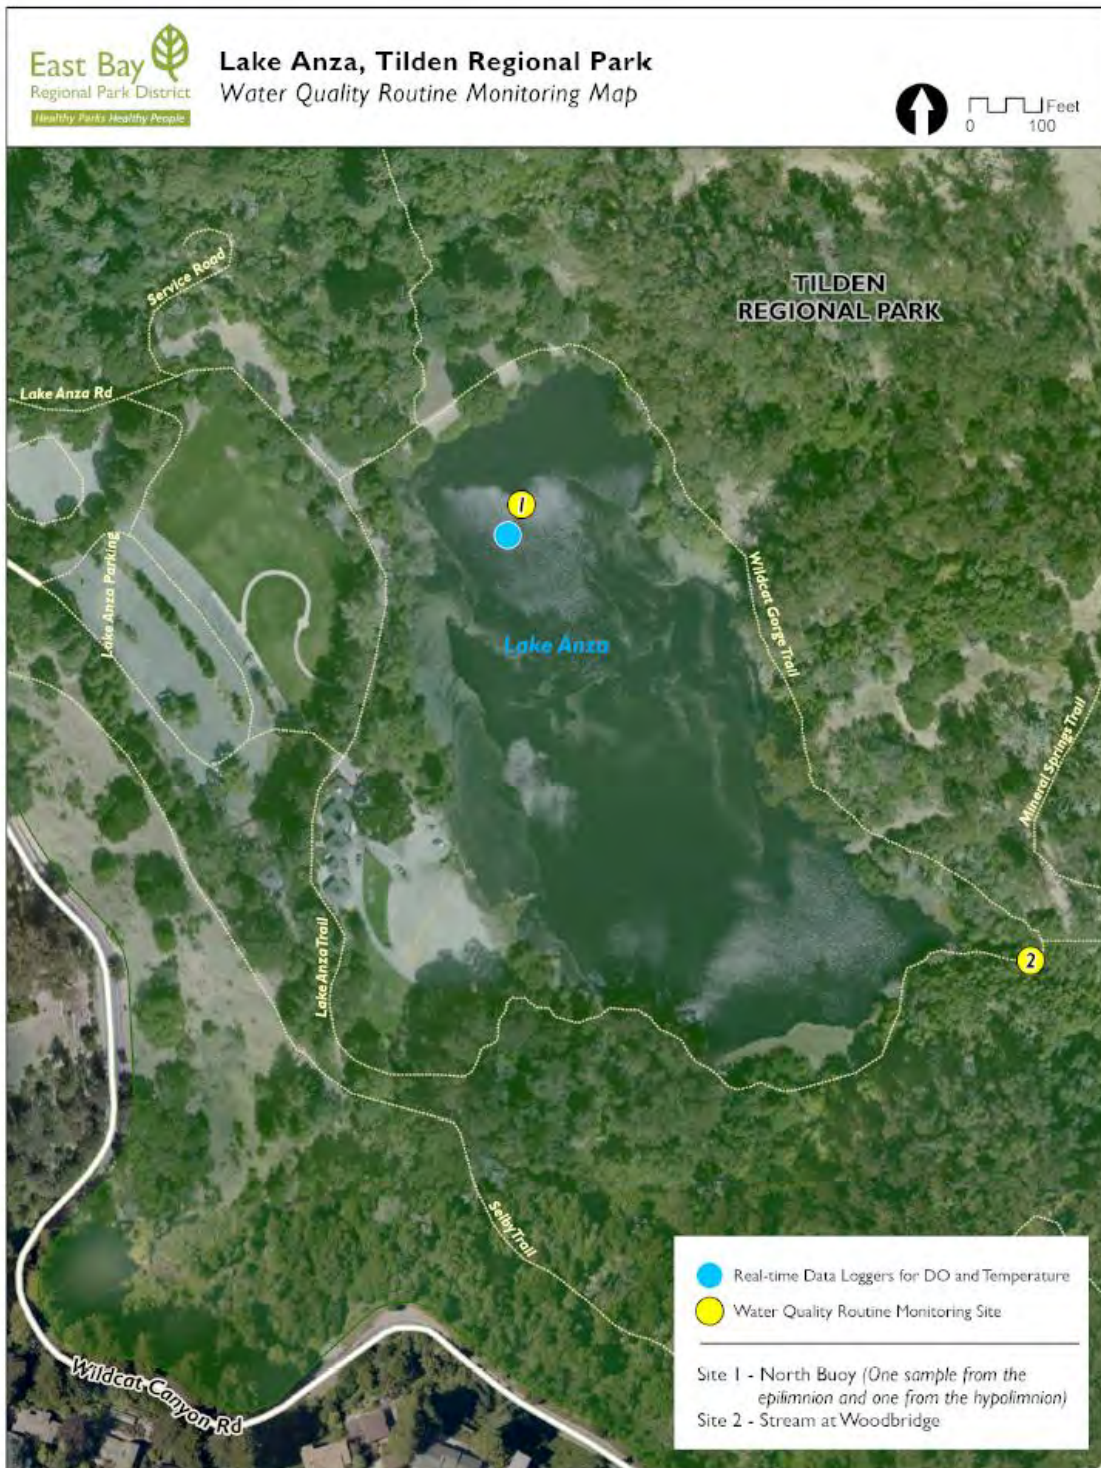
Figure 12. Anza watershed monitoring locations for monthly nutrient sampling. CU: Culvert, CO: Caldecott Outlet, NWD: Northwest Dock Epilimnion and Hypolimnion

There were three primary monitoring methods employed at Lake Anza: weekly HAB monitoring, real-time dissolved oxygen and temperature data reported from permanently deployed data loggers, and monthly depth profiles in conjunction with watershed nutrient monitoring. Weekly HAB monitoring encompassed a spectrum of tasks including visual observations, sampling, microscopy, and toxin testing. Real-time loggers are stationed at the deepest part of the lake and include a logger array at 1m, 3m, 4m, 5m, 10m, 11 and 12m. Monthly watershed nutrient monitoring was conducted at three locations, one, the incoming watershed and two locations at the deepest part of the lake, with samples being collected at 1m depth from the surface and 0.5m depth from the bottom of the lake.

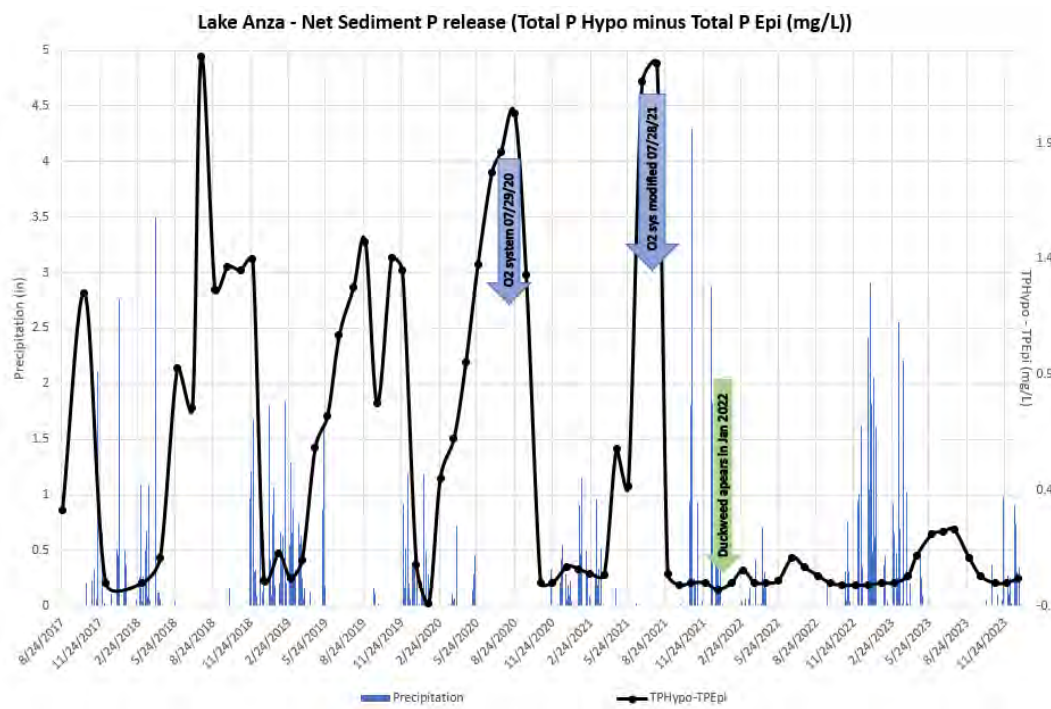
Figure 15. Phosphorus sediment release vs precipitation.

Figure 15 displays the net sediment P release (calculated by subtracting Total P at the epilimnion from Total P at the hypolimnion) since 2017. Even one year after the HOS was installed in 2020, a large net sediment P release was noticeable. This was caused by a 1-meter gap between the diffuser pipe and the anchor. This setup was modified in July of 2021, when the diffuser pipe was attached directly to the anchor. While this new setup decreased the sediment release during the following years drastically, we can still see slight net sediment P releases over the summer months, slightly higher in 2023.

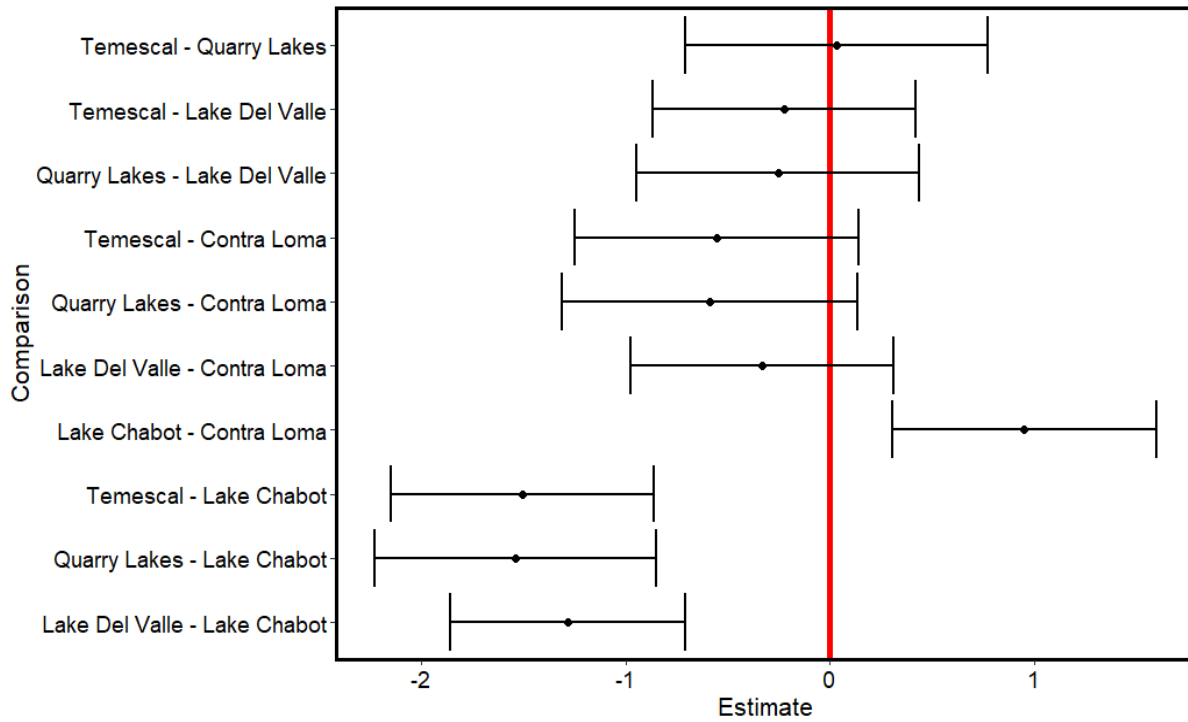
Figure 16. Stepwise comparison of Microcystin toxins detected in liver tissue of largemouth bass collected across five lakes. No overlap with the red line indicates statistical significance.

All samples were collected by Park District fisheries biologists and analyzed by Bend Genetics Lab. Much like 2022, a stepwise comparison of this year's results shows that liver samples from Lake Chabot fish were significantly higher in Microcystin toxins than that of fish collected in all other waterbodies (**Figure 16**). Liver samples collected since 2016, however, showed no significant differences in microcystin when grouped by year (**Figure 17**).

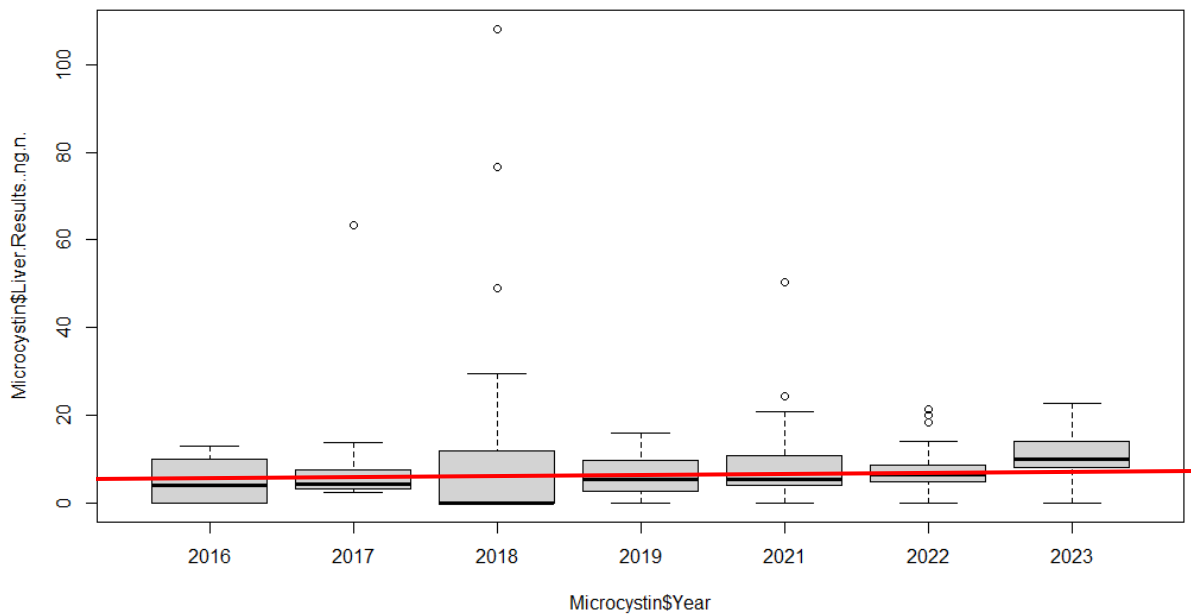
Figure 17. Microcystin toxins detected in liver tissue of largemouth bass annually across five lakes. No overlap with the red line indicates statistical significance.
