# An Updated Assessment of Trail User Compliance and Trailside Erosion in Wildcat Creek, Tilden Regional Park, Berkeley California

Jennifer Podvin  
2014

East Bay Regional Park District Report

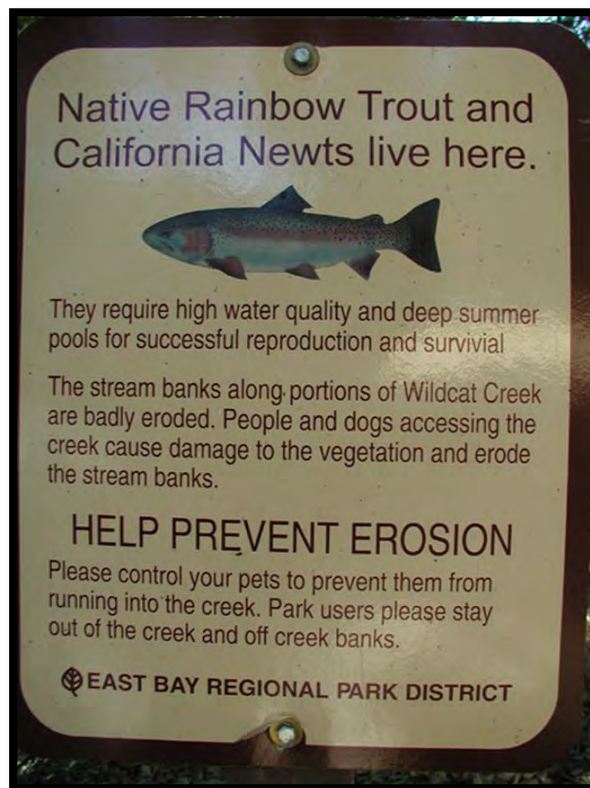
As a result of these findings, EBRPD erected 12 educational signs along Wildcat Gorge Trail informing the public about sensitive trout and newt habitat (fig 1). The district did not change any laws at this time; the hope was that the public would comply with educational signage without having to apply what some might consider heavy-handed tactics such as leash laws or excluding dogs from the trail all together. Brumbaugh (2002) finished his summer internship by observing park visitors and their dogs to evaluate the effectiveness of the new signs. He concluded that the signs were somewhat effective in curtailing people and dogs from entering Wildcat Creek.

**Figure 1: Educational signs erected along Wildcat Creek in Tilden Park informing visitors of sensitive creek habitat.**
